CAPSULE SUMMARY CT-1110 PROUT BARN A

and/or common Prout Barn A

7. DESCRIPTION CT-1110

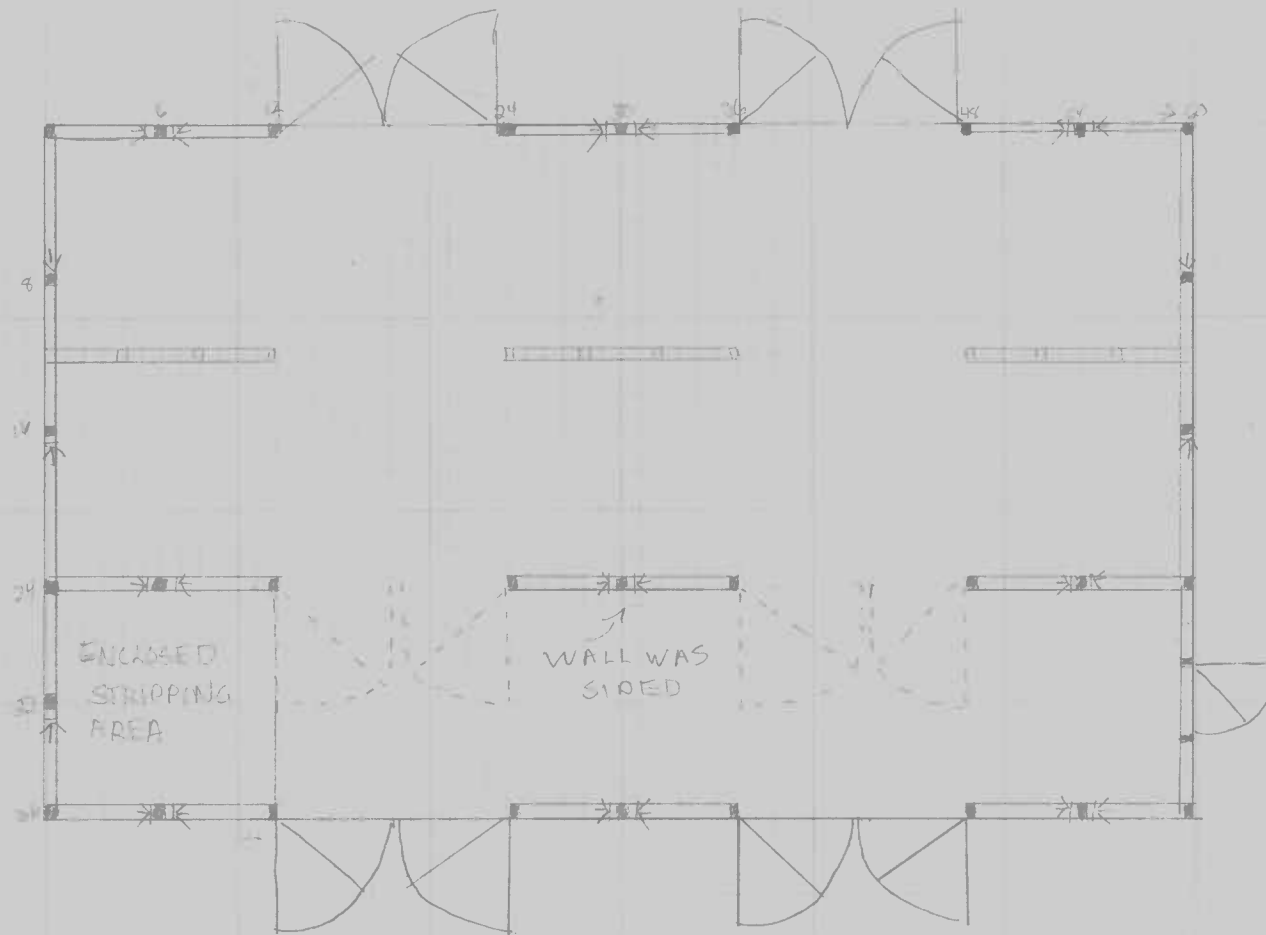
PROOT/OGDEN #2082 5/5/90

Barn frame is supported on cinder block masonry piers. A light timber frame on continuous sills sits on these blocks. Circular sawn timbers with wire nails, all joints toe-nailed. Vertical wall siding covers the exterior of the barn. Hinged ventilation doors, six on west, two on south, none on north. Rafters are on four foot centers and rest on a flat false plate. Top plate is toe-nailed. There are windbraces on four corners and in center of barn. Three collars. Boards are underneath the current standing seam metal roof. Tar paper is evident in some places. Tier poles are peeled logs separated by forty-one and one-half inches vertical distance. Poles down the central axis are two two by six inch boards nailed to the tie beam with blocks inserted between. Braces on either side of two drive-through aisleways.

The west shed is supported on cinder block piers. The framing materials are the same as those used in the barn. Vertical wall siding with six hinged ventilation doors on the east side covers the exterior. The roof is covered with standing seam metal, but there are boards underneath that were at one time covered with tar paper. There is a stripping room in the southeast corner of the shed that has three windows on the south side. The shed probably post dates the barn as there were once doors and siding on the west wall of the barn.

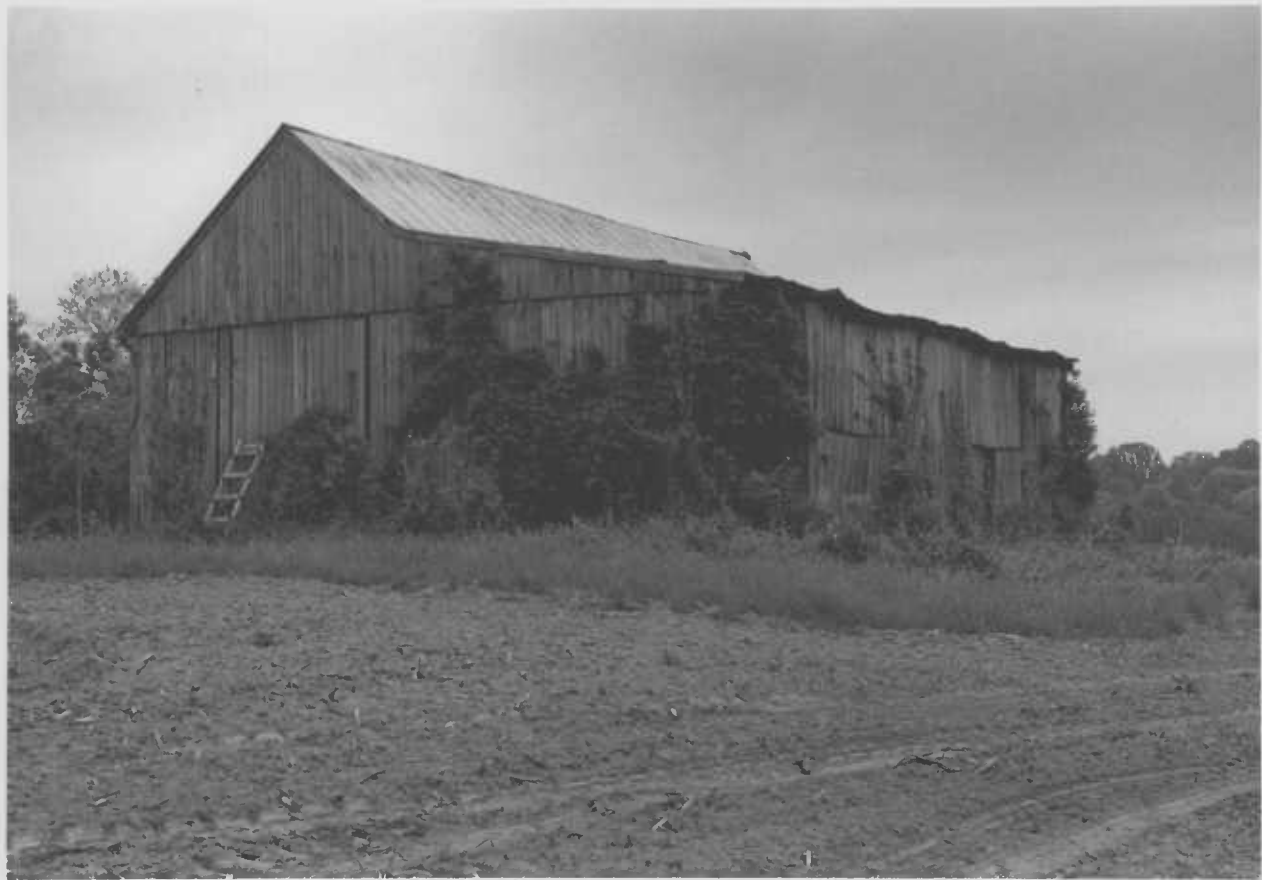
CT-1710 Prout Barn 'A'

Southwest
